[Docket No. FAA-2012-0807; Directorate Identifier 2011-NM-191-AD; Amendment 39-17888; AD 2014-13-12]

Airworthiness Directives; Airbus Airplanes

ACTION: Final rule.

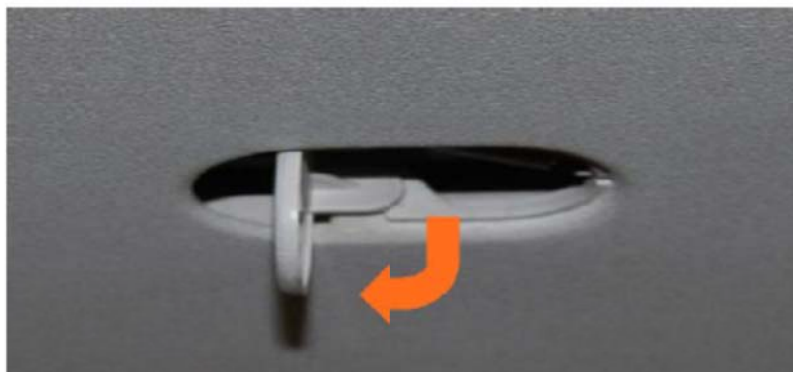
Picture B:

(7) The requirements of paragraphs (g) and (h) of this AD apply only to passenger oxygen containers that are Design A, as defined in figure 1 to paragraph (i)(7) of this AD.

Design A: The placard on the passenger oxygen container test button is as described in Picture A of Appendix 1 of this AD. The Mask configuration ("ZZ" in Picture A) is a number and the test button is as shown in Picture B.
